Survey on the Flood in *Iiyama* City Caused by Typhoon No. 19 of 2019 (Typhoon “*Hagibis*”)

K. Asano, T. Kaneko, K. Ueno, H. Maruyama, H. Yamamoto, N. Tateiwa
Nagano Prefecture *Iiyama* Senior High School Science Club

1. Activity

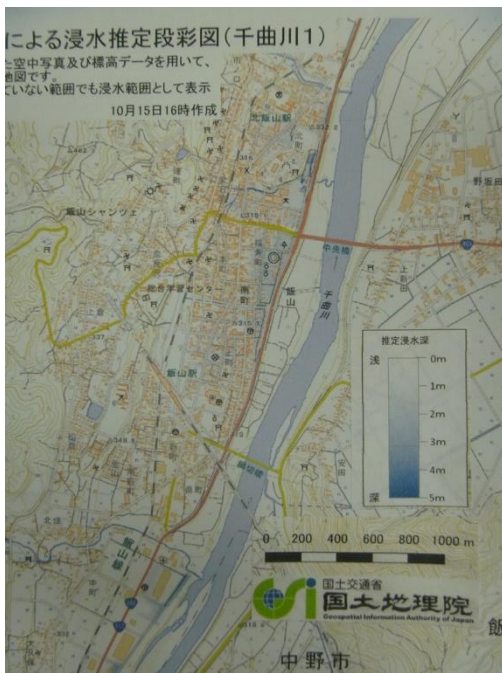
Fig. 1 Stage Diagram of Presumed Inundation Depth (Geographical Survey Institute)

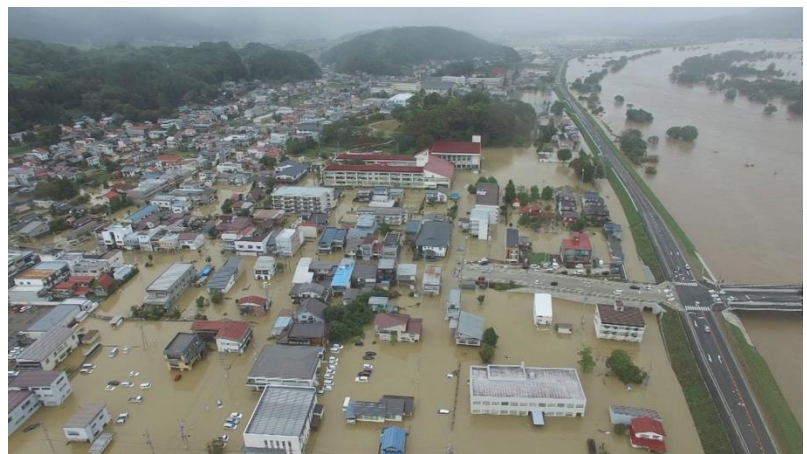
Fig. 2 Flood Damages to Iiyama City (1:00PM, Oct. 13th, provided by iNet)

- Damages to flooded houses
38 largely destroyed, 152 half destroyed, 24 partially destroyed, 416 partially damaged (less than 10% damaged), total 630
- Damages to flooded office buildings
147 (Including houses accompanying stores, and those that only have damaged warehouses and/or vehicles)
- Damages to public facilities related to civil engineering
64 points of road, 6 pieces of equipment related to roads (snow-melting pipes, control panels)

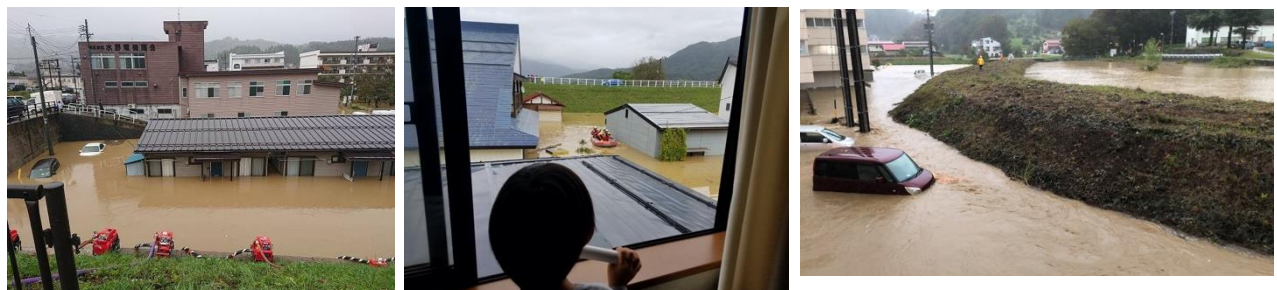
Fig. 4 Photographs of the Iiyama Flood

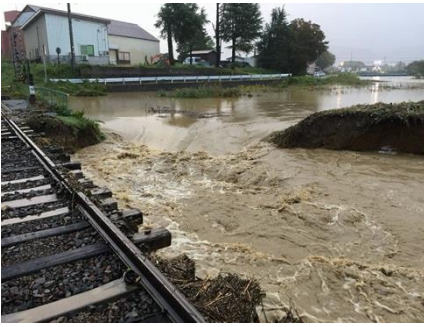
Fig. 5 Collapse of the Sara-gawa River
(6:00AM, Oct. 13th)

4:15AM Sara-gawa River collapses, water level drops in left bank dam

- **The Inland water flood was due to the bank of the *Sara-gawa* river, a branch of the *Chikuma-gawa* river, collapsing.**

We do not know the main cause of the *Sara-gawa* river overflowing. The *Sara-gawa* river flows into the *Chikuma-gawa* river through the *Himon* gate. However, according to the “*Hakomise-ya yokocho oya no miseban nikki*”, the gate was closed at 1:44AM, October 13th, and the operators have evacuated. The problem is whether the *Sara-gawa* river itself overflowed, or water from the *Chikuma-gawa* river flowed upstream into it. A firefighter from the *Gakuhoku* Fire Department has reported that “there was a reverse flow from the *Himon* gate into the *Sara-gawa* river”, but there is no official opinion about the fact.

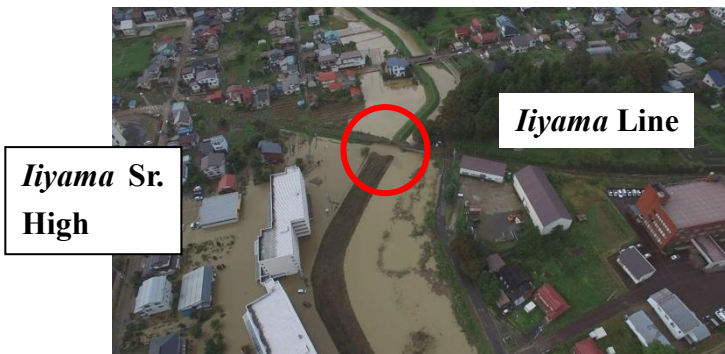
Fig. 7 Site of Sara-gawa Collapse (provided by iNet)

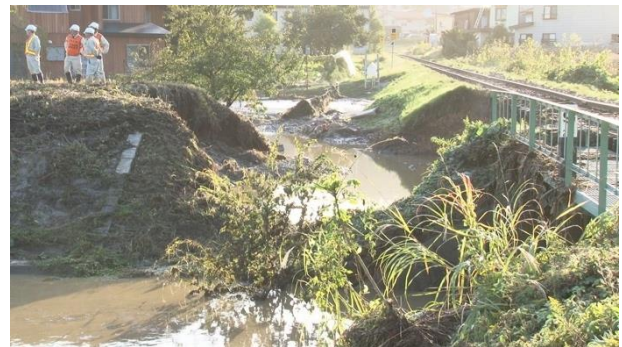
Fig. 8 Site of Sara-gawa River Collapse (Oct. 14th)

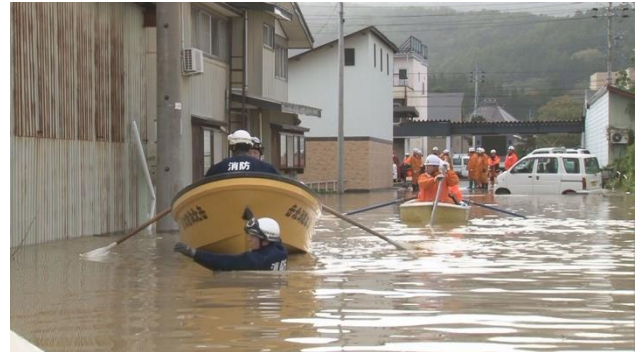
Fig. 9 Fukujumachi Ward (3:00PM, Oct. 13th)
The water level was at its maximum at this time.

6:40AM Evacuation Advisories announced on *Fukujumachi, Honmachi, Sakanamachi, Kanmachi, Shinmachi, Teppoumachi, Narazawa, Sakaemachi, and Agatamachi* wards, *Iiyama* region, and *Kitabata* ward, *Akidzu* region due to high flow exceeding processing capacity of pump

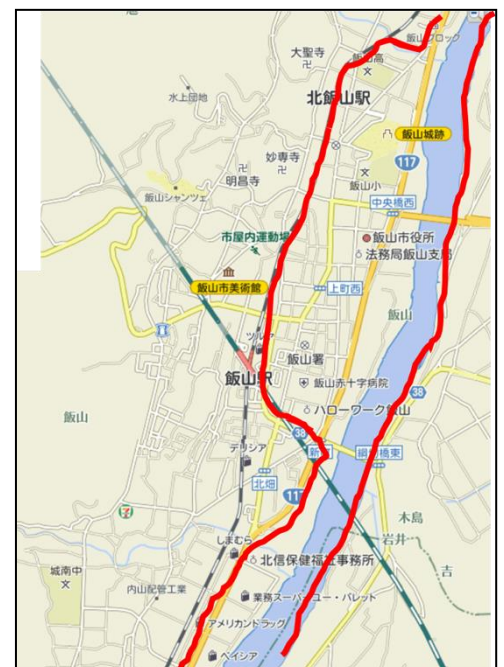
We have plotted the area of flooding in *Iiyama* city based on the image reported on *TV Tokyo* (Afternoon of October 13th) (www.youtube.com/watch?v=mQUmaD5mWEc). The area surrounded in red in Fig. 10 has flooded during the disaster.

Fig. 10 Range of flooding in
Iiyama City
